3.0 AFFECTED ENVIRONMENT

Phipps Ocean Park Beach Restoration Project COASTAL TECH <small>VERO BEACH · GARCASOTA · MELBOURNE · DUSTIN · AUSTIN</small>		PLAN VIEW Lake Worth Inlet to South Lake Inlet <small>ENOR</small> MPW <small>REVISOR</small>	Figure 3.1 <small>JOB NO.</small> 93714 <small>DATE</small> 4/2/2002
--	--	--	--

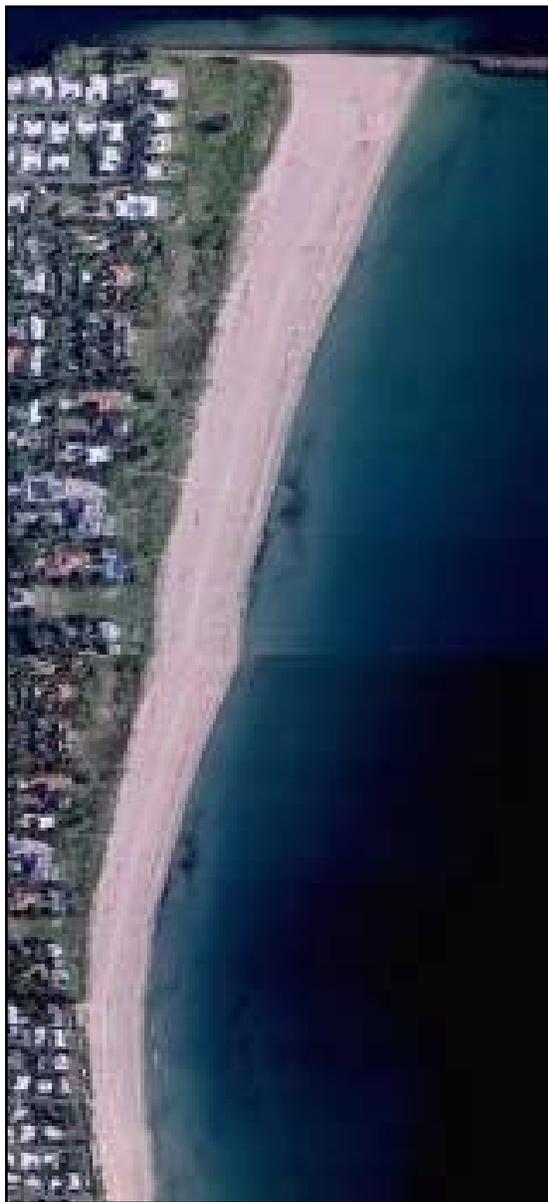
Figure 3.7 Reach 1, South of Lake Worth Inlet Extending South (March 2001)

Reach 1: This reach is located immediately south of Lake Worth Inlet and includes about 2,400 feet of shoreline (Figure 3.7). The shoreline change and volumetric data indicate the beneficial effects (shoreline advance) in response to this nourishment.

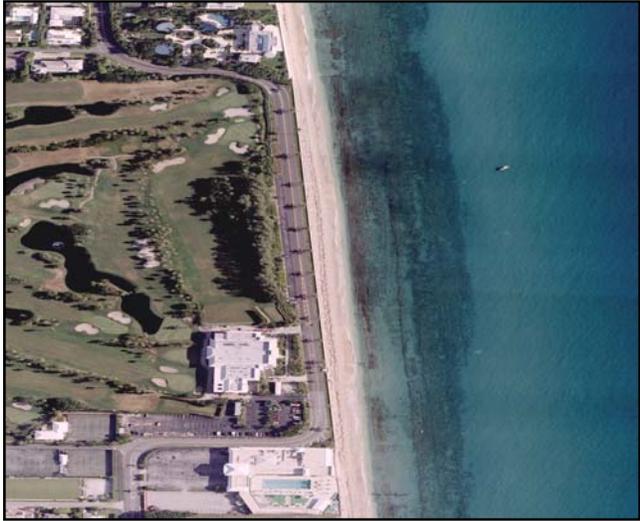
Figure 3.8 Aerial Photograph of Reach 2 at Palm Beach Country Club (March 2001)

A seawall and a narrow beach front much of the shoreline in Reach 2, located at the Palm Beach Country Club near reference DNR Monument R-85 (Figures 3.8 and 3.9). Any seawall, rock revetment or other armoring prevents erosion of the dune and upland areas but also deprives the beach of littoral sediments.

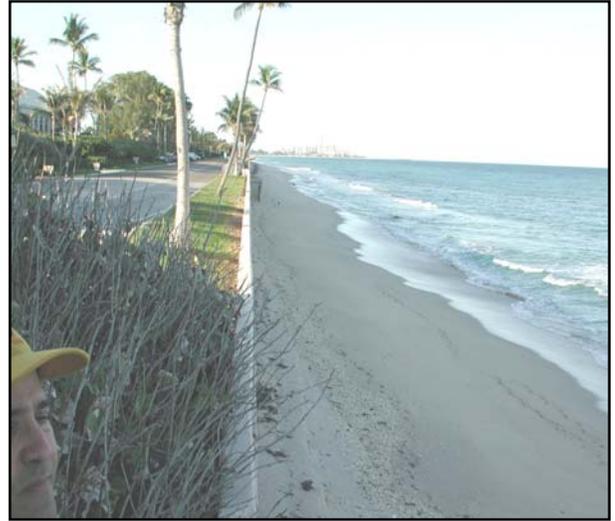
Figure 3.9 The Narrow Beach Front Along Reach 2 at Palm Beach Country Club (February 2002)

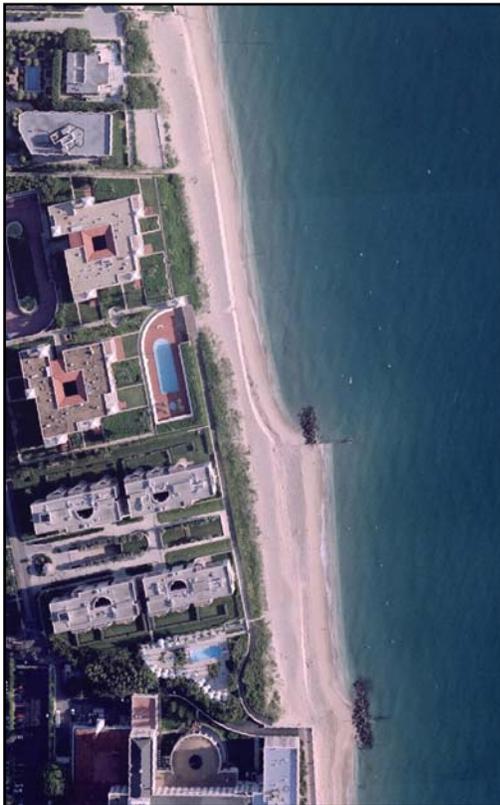
Figure 3.10 Reach 3, Breakers Hotel (March 2001)

Reach 3: Reach 3 extends over 5,800 feet of shoreline and is almost completely fronted by seawalls (ATM, 1998). The southern end of Reach 3 includes several groins at the north end of the Breakers Hotel (Figure 3.10). The seawalls and groins can deter updrift erosion and translate the longshore transport deficit to downdrift beaches.

The volume change data indicate annual losses from Reach 2 at about 55,000 cy/yr from 1929 to 1957. Reach 2 gained sediment between 1974 and 1990, but eroded at about 86,000 cy/yr from 1990 to 1997.

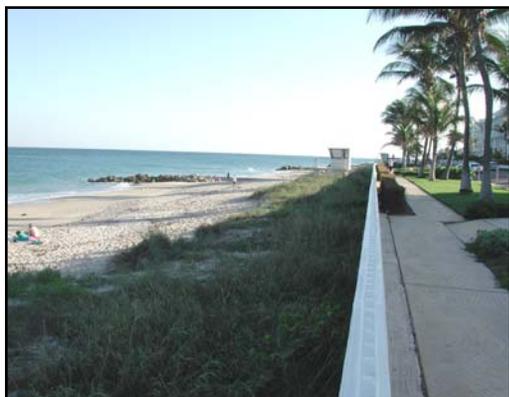
Figure 3.11 Reach 4, Mid-Town Region, (February 2002)

Reach 4: By 1987, over 80% of the shoreline in Reach 4 was fronted by a seawall (Figure 3.11). Virtually the entire shoreline included groins (Olsen, 1987). In December 1995, the Mid-Town Beach Restoration project was completed in Reach 4 (Dean, 1997). About 800,000 cubic yards of sand were placed on the beach between DNR Monuments R-95 and R-100. The fill area includes a groin field constructed from coquina rock and from concrete “PEP reef” units obtained from a previous experimental project.

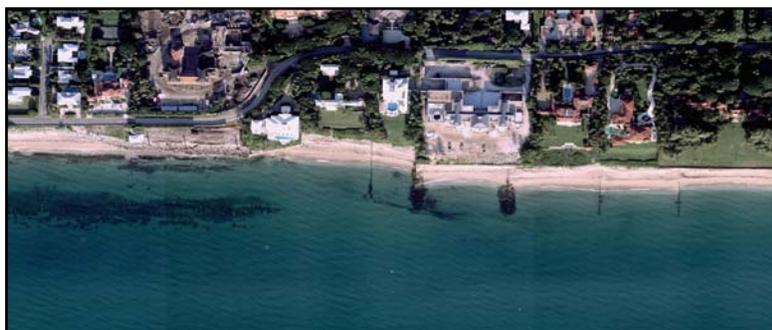
Figure 3.12 Aerial Photograph of Reach 5 at Widener’s Curve (March 2001)

Reach 5: By 1987, over 80% of the shoreline in Reach 5 was fronted by a seawall or a rock revetment. The entire shoreline included groins (Olsen, 1987),

which have significantly affected the shoreline (Figure 3.12). The “Monster Groin” (near DNR Monument R-110) improves the stability of the shoreline to the north in Reach 5, but deprives sand to the downdrift beaches in Reach 6.

likely fill the beaches and advance the shoreline updrift of major headland features such as at the Breakers Hotel, "Monster Groin," and groin fields in Reaches 5 and 6. Subsequent to this filling at each headland feature, longshore transport to downdrift beaches would then be restored. The timeframe to achieve this filling process is uncertain, but would occur from north to south. Since restoration of the sand transfer plant in 1996, the beach north of the Breakers Hotel does not appear to have become fully impounded (see Figure 3.10 and description for Reach 3). It is hypothesized that more than 50 years would be required to fully impound existing artificial and natural headland features and restore longshore transport on the island through improved sand transfer at Lake Worth Inlet. In such a scenario, beaches downdrift of the headland features would theoretically be expected to remain stable in their current condition after all headland features became filled.

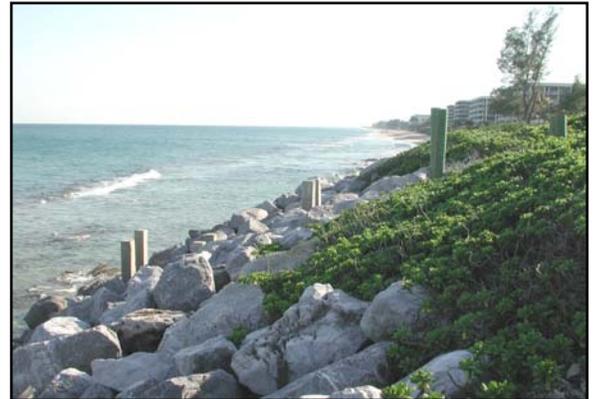
Figure 3.13 Rock and Groin in Reach 6 (February 2001)

In 1987, the FDOT constructed a rock revetment along the shoreline in Reach 6 to protect the upland road (Figure 3.13). The rock revetment and groins have further “hardened” the shoreline in Reach 6, deprived the downdrift beaches of sand, and translated the longshore transport deficit further south into the Phipps Ocean Park Beach Restoration Project Area. The volume change data indicate that Reach 6 eroded at about 7,500, 15,000, and 46,000 cy/yr from 1929 to 1957, 1974 to 1990, and 1990 to 1997, respectively.

Without placement of additional sand fill, the Town's beaches are expected to continue to erode to the face of the existing seawalls and revetments. This condition now exists in Reach 6 (Figure 3.13 and description for Reach 6). Sand placed in Reach 1 is expected to work its way downdrift to South Lake Worth Inlet through littoral processes.

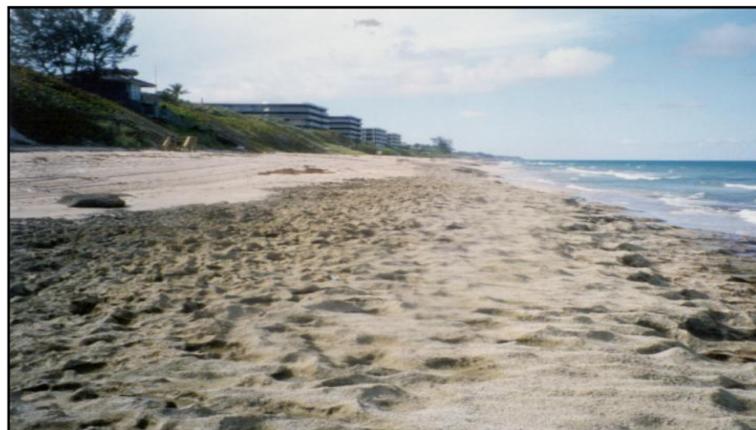
Figure 3.14 Exposed Anastasia Formation in Reach 7

Reach 7: Sloan’s Curve is located at the northern boundary of Reach 7. The 3 miles of shoreline immediately north of Sloan’s Curve and Reach 7 are fronted by numerous armoring structures including rock revetments, seawalls, and groins. The Mid-Town Beach Restoration Project is also located to the north of this 3 mile segment. In combination with the effects of Lake Worth Inlet, the armoring structures along this 3 mile segment have caused a significant longshore transport and sediment deficit to the proposed Project Area. The resulting erosion has exposed the Anastasia Formation in the form of nearshore hardbottom and emergent rock (Figure 3.14).

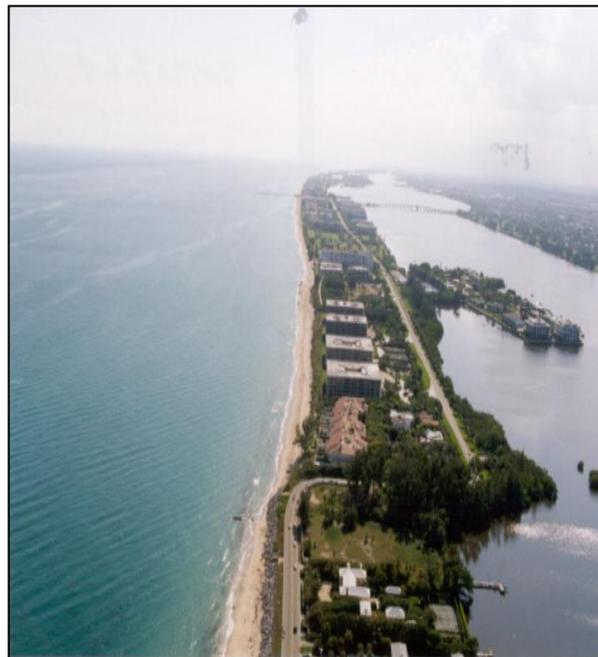
Figure 3.15 Oblique Aerial Photograph of The Concave Shoreline in Reach 7 (1999)

Prior to construction of Lake Worth Inlet in 1925, FDEP historical shoreline data indicated that the shoreline was significantly more seaward than its present position. In the vicinity of the proposed Phipps Ocean Park Project (DNR Monument R-120 to R-122), the shoreline has receded by about 200 feet since 1878. This recession has resulted in the current “concave” shoreline where the shorelines at the northern and southern boundaries are further east than at the mid-point (Figure 3.15).

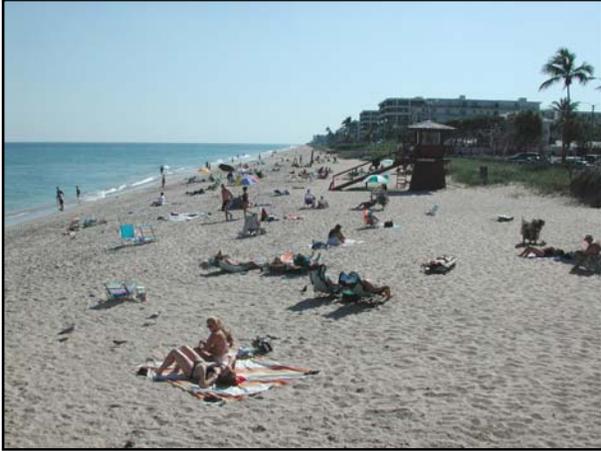
Figure 3.17 Exposed Seawall Near R-135 (Reach 8)

Reach 8: Reach 8 is the southernmost reach within the Town of Palm Beach. By 1987 about 65% of Reach 8 was fronted by seawalls (Olsen, 1987). Many of these seawalls are now buried under the beach berm or dune likely due to windblown sand or dune restoration activities such as at Lake Worth Public Beach (Figure 3.16). At the southern limits of Reach 8, the existing seawalls are located in close proximity to the shoreline (Figure 3.17).

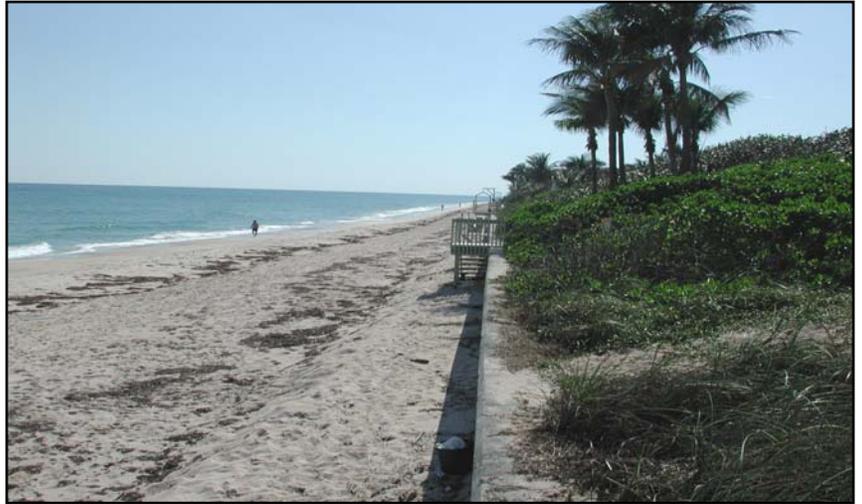
Figure 3.18 Typical Beach and Seawall Conditions Near R-143 Along Reaches 9 & 10

Reaches 9 and 10: South Palm Beach and the public beach at Lantana comprise the 3,550 feet of shoreline of Reach 9. The northern 8,300 feet of shoreline in the Town of Manalapan form Reach 10 (ATM, 1998).

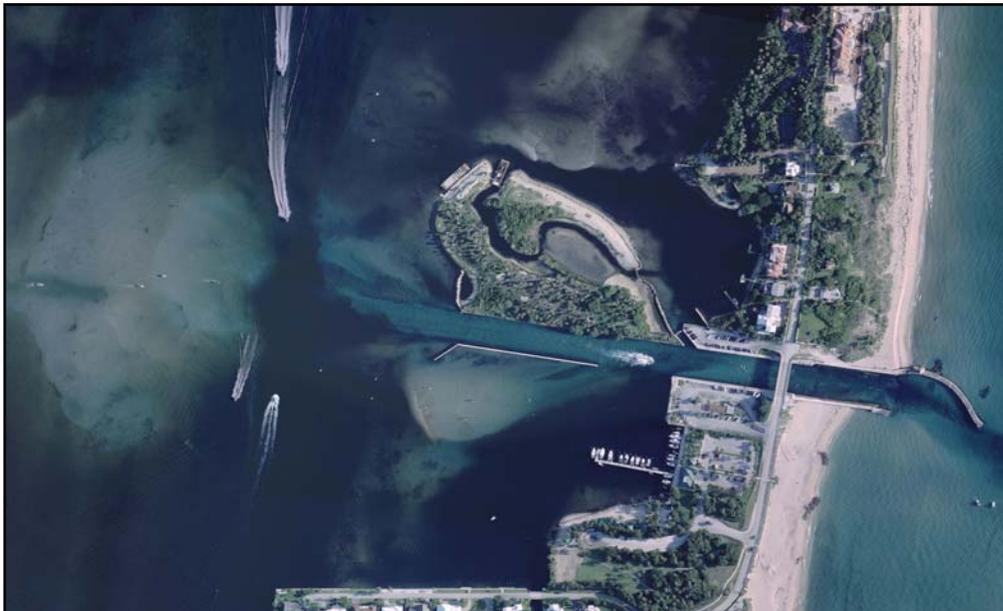
Figure 3.19 South Lake Worth (Reach 11)

Reach 11: South Lake Worth Inlet is the southern boundary of Reach 11. By 1987 over 50% of this Reach was fronted by seawalls (Olsen, 1987). The volume change data indicate annual losses from Reach 11 at approximately 22,000 cy/yr from 1929 to 1957. Reach 11 gained sand at approximately 2,500 cy/yr between 1974 and 1990, but eroded at about 4,500 cy/yr from 1990 to 1997. The data indicate that the shoreline of Reach 11 is reasonably stable. This is apparently as a result of the updrift stabilizing influence of the north jetty at the Inlet (Figure 3.19).

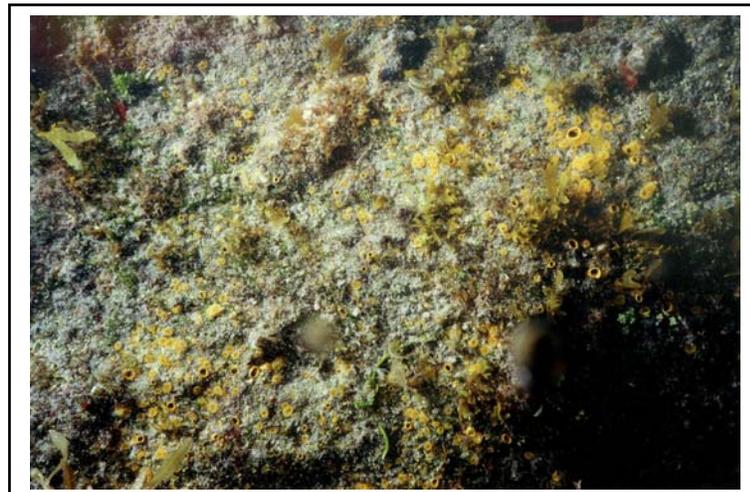
Figure 3.21b Typical Nearshore Algal Fouling Community, Still Photo, DNR Monument R-91

In January and February 2000, the natural nearshore and intermediate depth hardbottom characteristics were documented by collecting video data and still photos along 31 transects established perpendicular to the shoreline within the Project Area (CSA, 2000). The transects were plotted between DNR Monuments R-113 and R-128, and water depths along the transect ranged from 4 to 30 feet. Video documentation was recorded using Integrated Video Mapping System (IVMS) and a diver towed behind a boat using surface-supplied air and a high-resolution color video camera (Figures 3.21a and 3.21b).

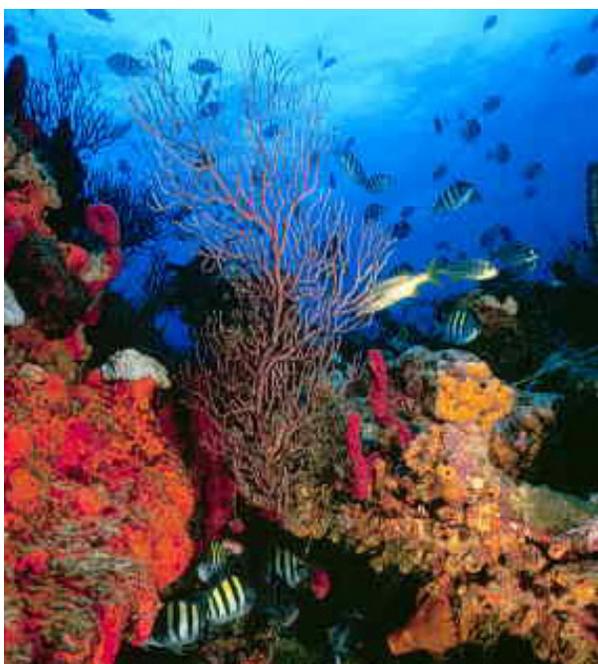
**Figure 3.23 Typical Offshore Hardbottom
Habitat Breaker's Coral Reef,
DNR Monument R-94**

The Breaker's Reef is located offshore of DNR Monument R-94. The reef is not located within the area of impact for either the borrow or placement areas for the Applicant's Preferred Alternative.
